CVT Oil Pan Change

Affected Models: 2010 and 2011 Kizashi with Continuously Variable Transmission (CVT)

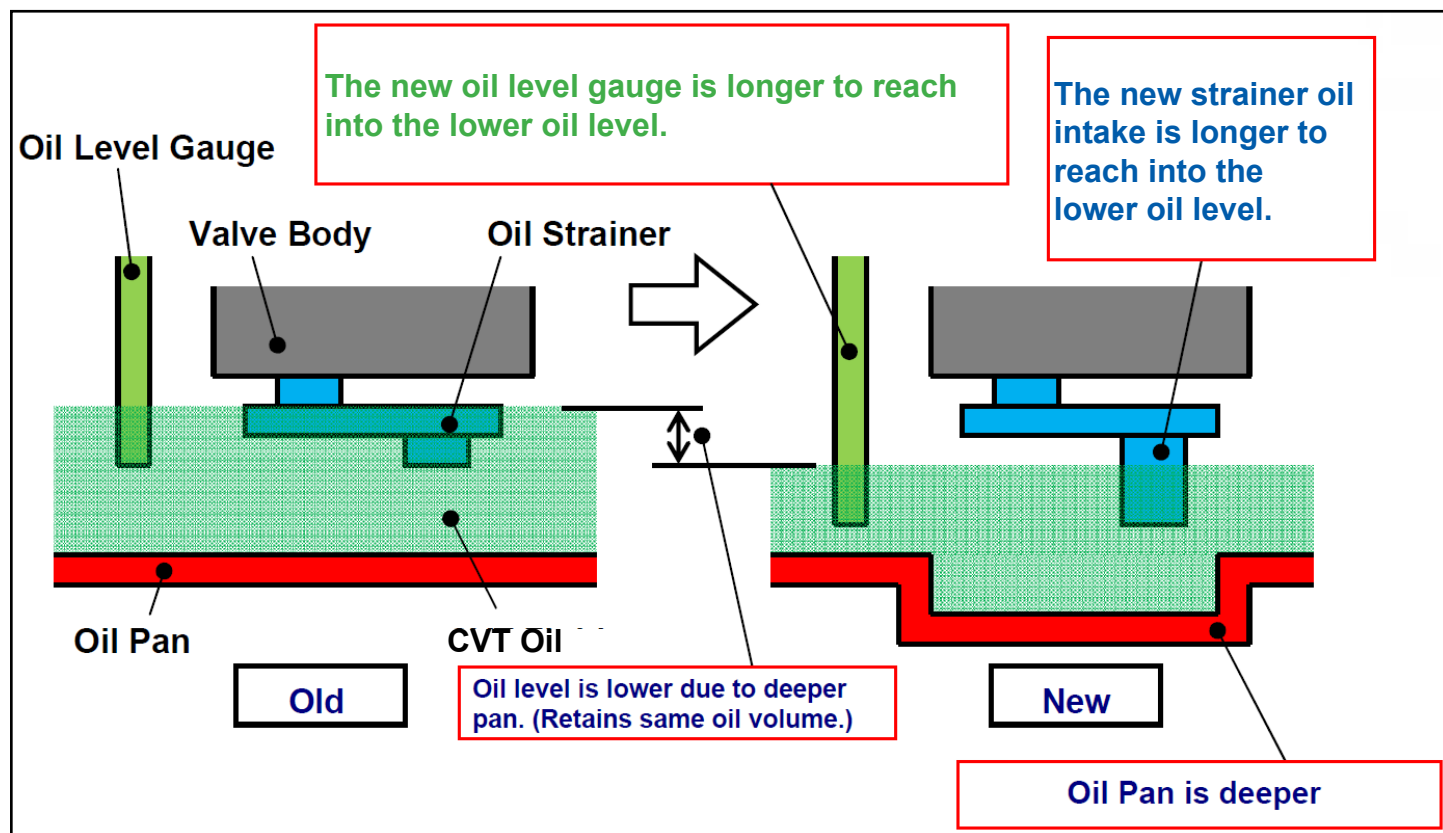
Condition: Customer may report a loss of engine power during periods of high speed driving, pulling heavy loads, or driving steep grades and mountains .

Cause: When the CVT oil temperature becomes extremely high, the CVT Power Reduction function becomes active and engine power output is reduced.

Correction: Design changes to the CVT oil pan will maintain normal oil operating temperature longer. Design changes also include a revised oil strainer and oil level gauge.

If a vehicle has the condition described above, install the **New** components listed in the table below.

When replacing the Old oil pan with the New pan, always install a New oil strainer and New level gauge.
