Recall Campaign "CP"
Service Campaign Bulletin SC-76

June 1, 2018

SAFETY RECALL CAMPAIGNS 4005, 4006, 4007, 4008 CVT Controller Assembly Replacement

Affected Models: 2013 Kizashi and 2013 SX4**Affected Departments:** Management, Service, Parts, Warranty

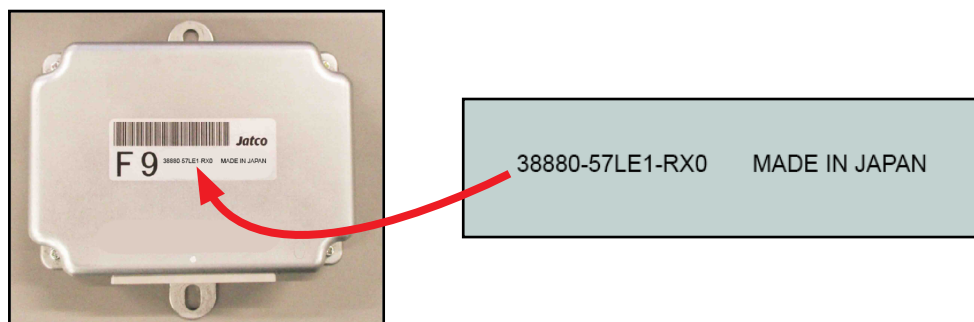
- Parts for this campaign are available now; order the necessary CVT controller assembly using part number chart provided below.
- The countermeasure CVT controller assembly can be identified by the **RX0** designation at the end of the part number. (See the illustration and chart below.)
- If you have any questions related to parts ordering, contact Suzuki National Parts Coordination at (714) 854-2165.
